CIVIL AERONAUTICS BOARD

AIRCRAFT ACCIDENT REPORT

AMERICAN AIRLINES, INC., BOEING 707-123B
N 7506A, JAMAICA BAY, LONG ISLAND, NEW YORK,
MARCH 1, 1962

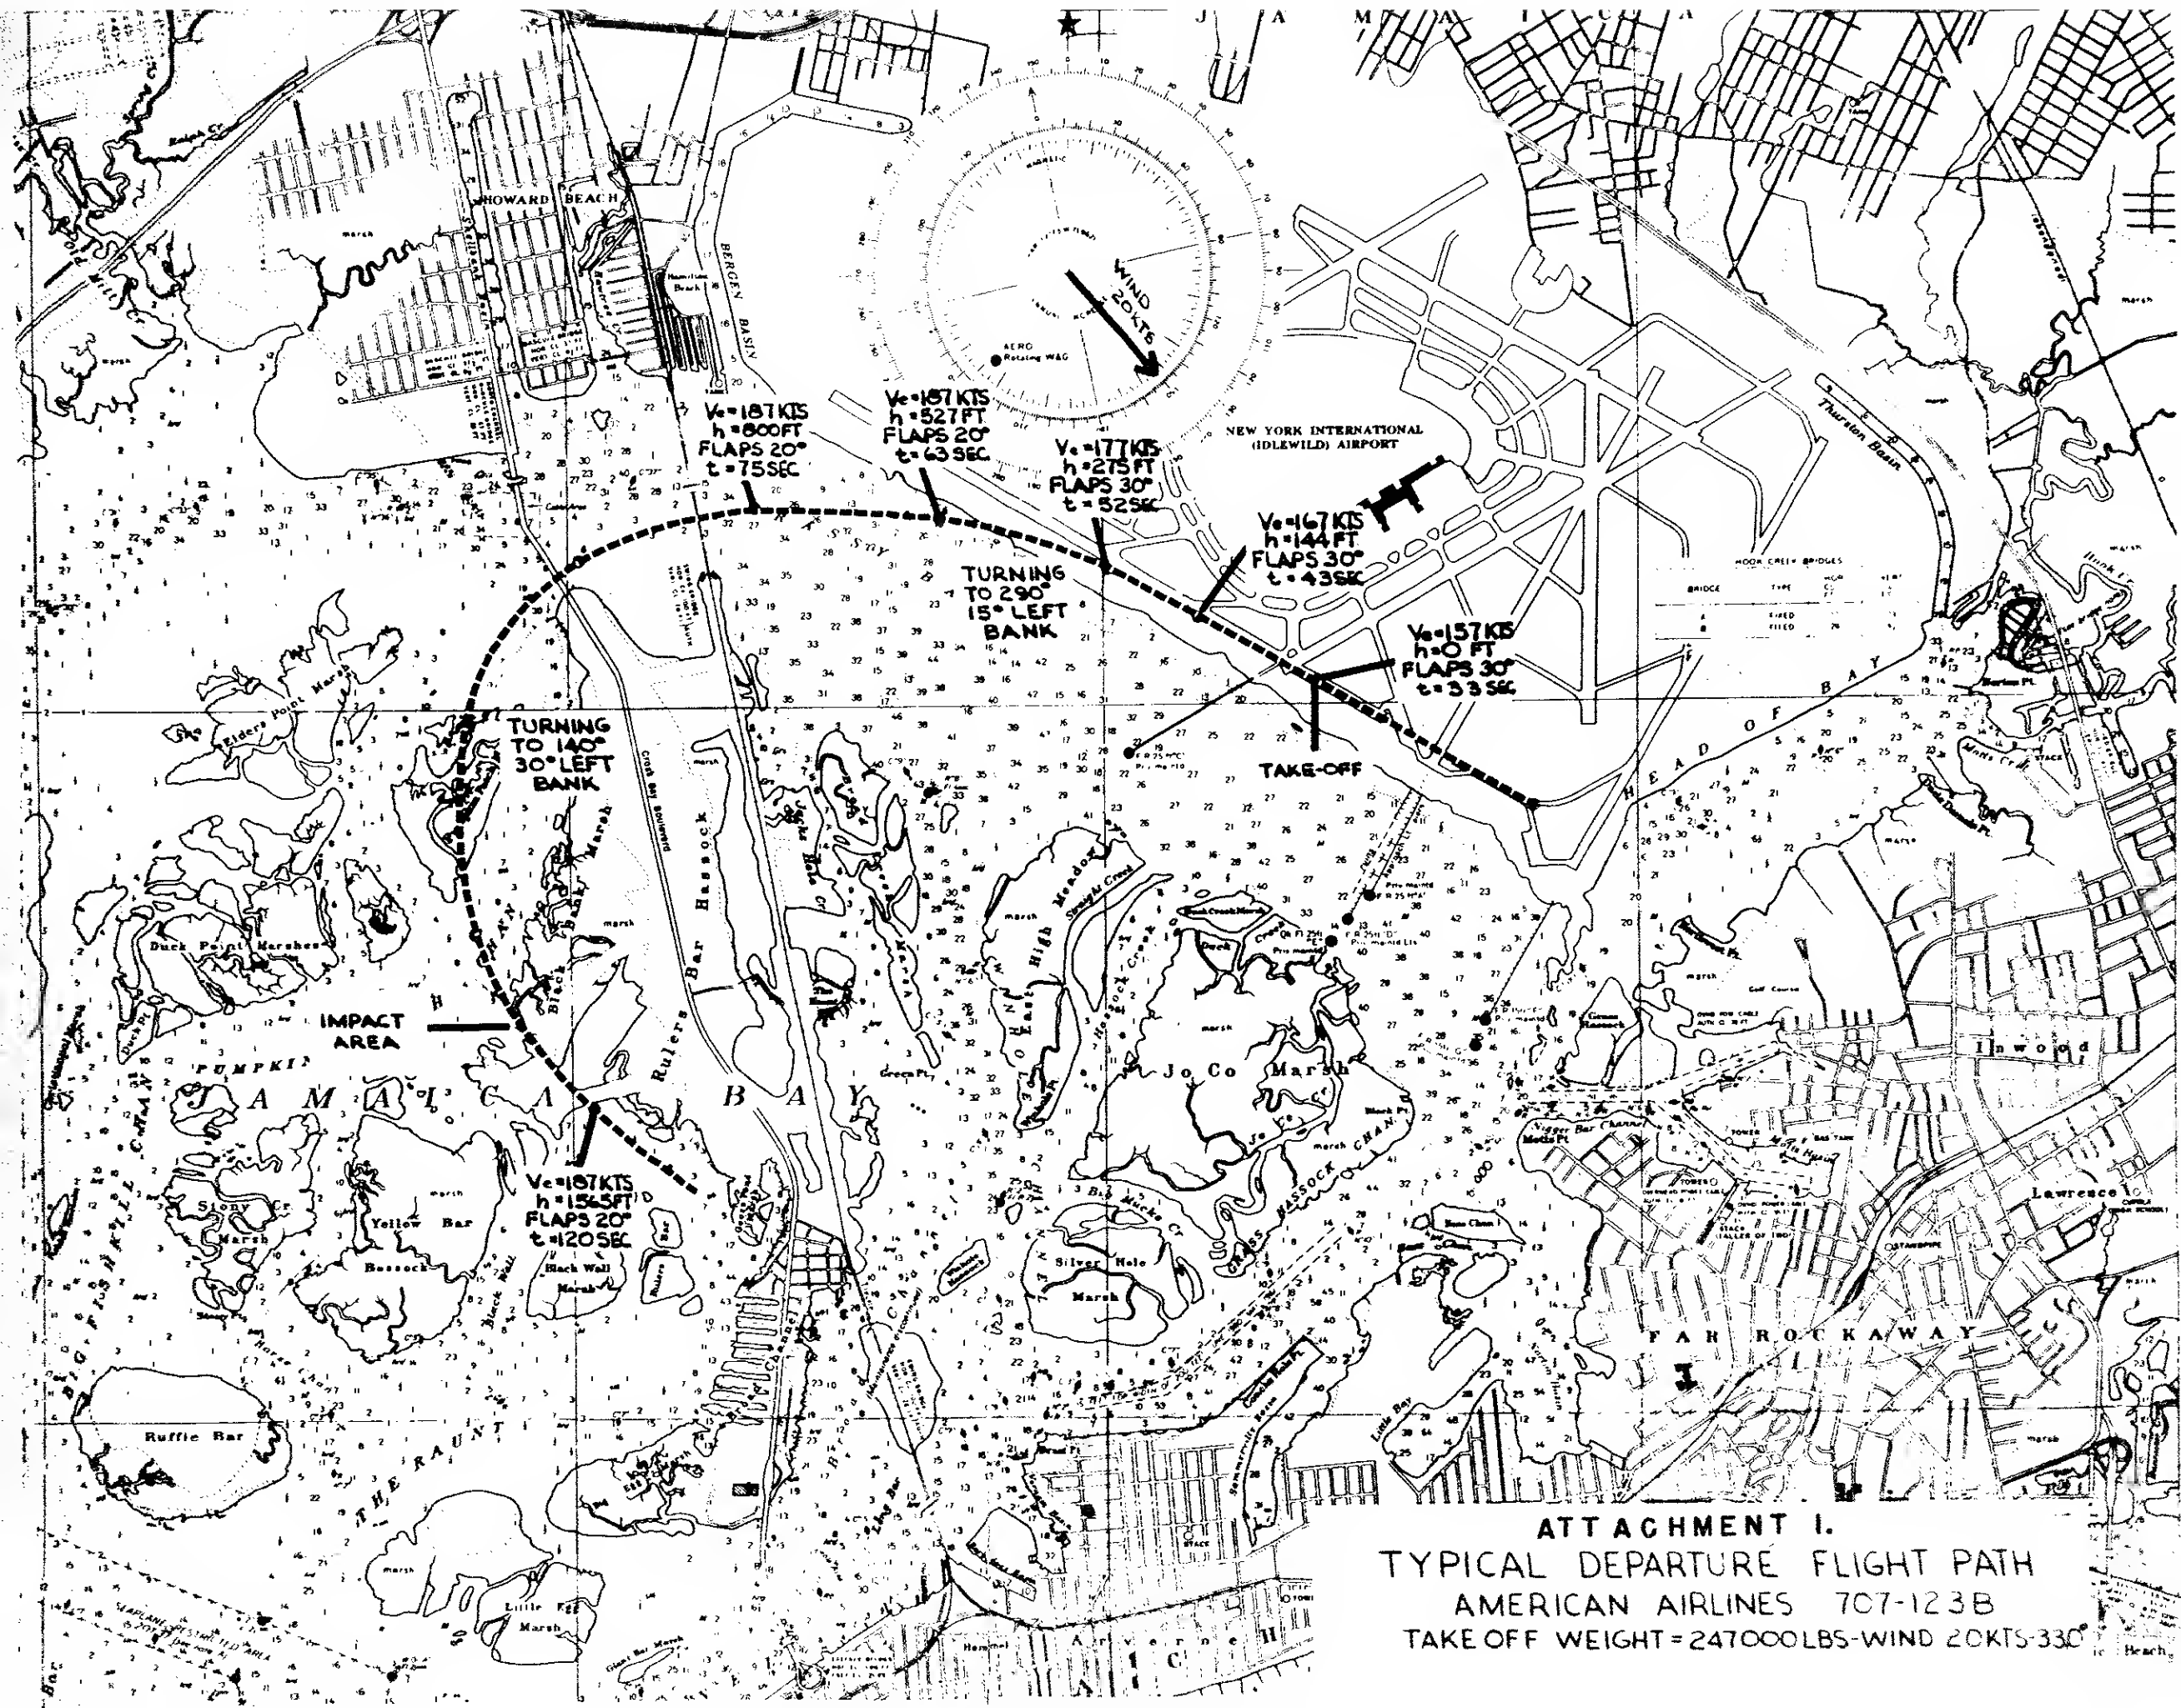
FLIGHT RECORDER DATA

At 1008:07, within six-tenths of a second, a heading change from 250 to 243 degrees is recorded; a change rate of 12 degrees/second, amounting to an instantaneous tripling of the 3.83 degrees/second change rate recorded just prior to this time. From 1008:08 to 1008:16 the heading trace passes through the badly wrinkled, abraded and torn portion of the foil, during which time the heading changed from 245 to 225 degrees. At time 1008:16, the heading trace emerges from the badly damaged portion of the foil and for the next one and one-half seconds indicates a much lower rate of heading change than that immediately preceding entry into the damaged area. The heading trace shows a momentary cessation of turn at 1008:19 followed by a higher turn rate continuing until 1008:31, when a sharp reversal in the recorded heading is noted. Such an abrupt change from a left turn to a right turn is beyond the aircraft's capability and is an indication of gimbale error in the directional gyro of the airplane as the angle of left bank approached 90 degrees. From this time to about 1008:42 the recorded headings are similarly in error due to the high roll and pitch angles of the airplane as it inverted and dove to the ground.

At time 1008:18, 1008:25 and 1008:29 the airspeed and altitude traces indicate sharp simultaneous increases which were beyond the aircraft's performance capability, and the highest peaks recorded indicate an airspeed of 230 knots and 2,000 feet of altitude at 1008:30. The precise significance of these recordings cannot be completely defined. However, a single static port low on the left side of the forward fuselage is connected to the airspeed and altitude sensors of the flight recorder. As a result, nose left sideslip (relative wind from the right) and high angles of attack cause appreciable plus errors in the recorded airspeed and altitude.
